GMB notes on killing 150Hz squelch tone on RT351-based Clansman UK/VRQ301

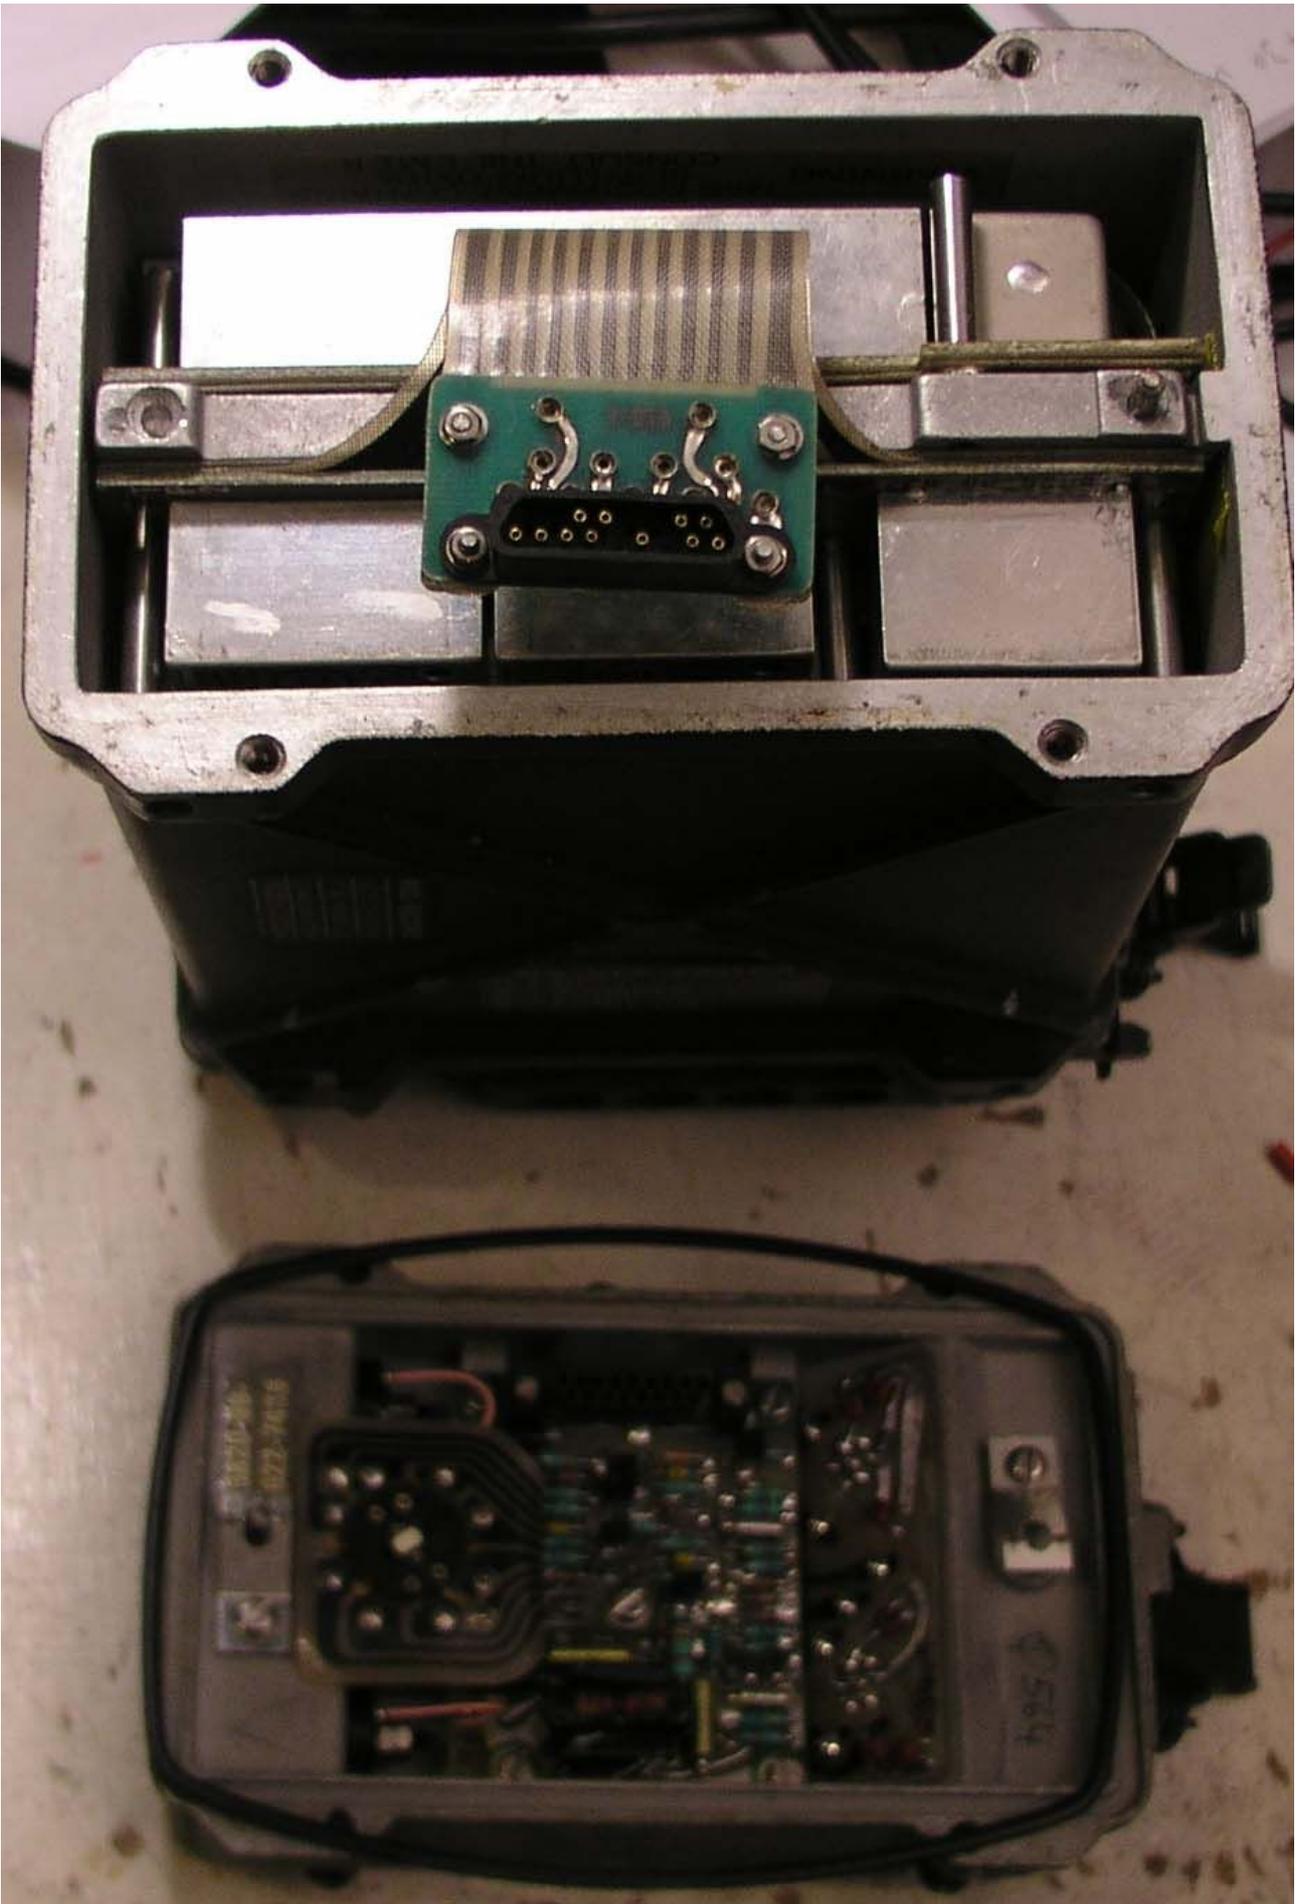
The deviation level of the 150Hz tone is set by R9 on module 13 (13R9) so just set that pre-set pot to zero by rotating anticlockwise. It turned about 180 degrees on mine.
NB: It's fragile so take care not to force it. It's very hard to fix if broken.
